Crack Growth Behaviour of Spur Gears:  
A Fractographic Analysis

DSTO-TN-0137

Airframes and Engines Division  
Aeronautical and Maritime Research Laboratory

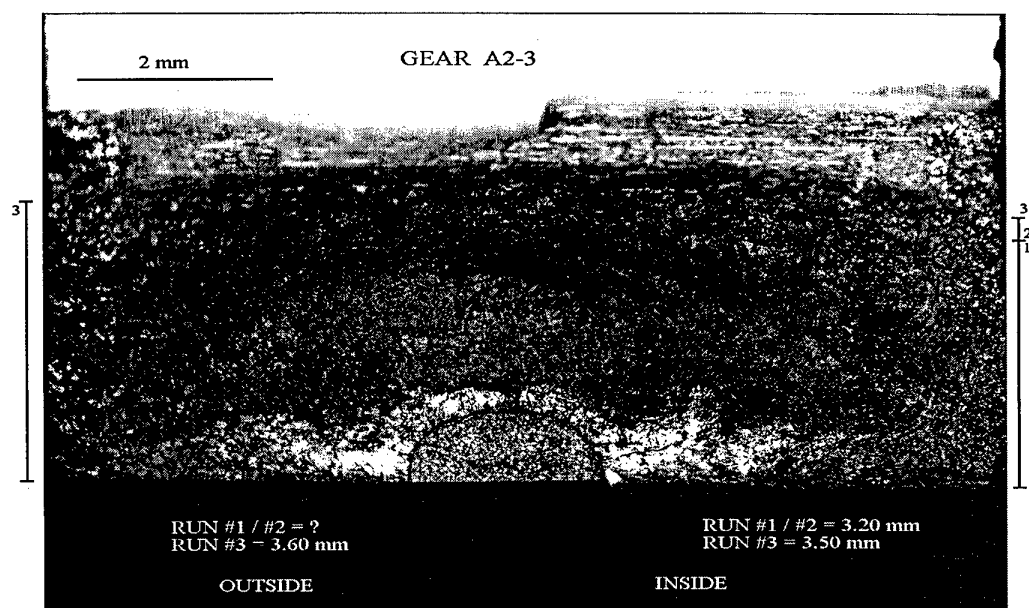
Staining can be seen clearly in Gear A2-3 and Gear A2-5. This made it even harder to see any prominent marks on the fracture. A similar problem occurred with the rubbing around the notch which can clearly be seen as the bright reflected regions in Gear A2-1 and Gear A2-5. Along the sides of most of the fractures there were some very bright regions. These actually correspond to the iron carbide particles formed during the carburising of the gears. There were more distinguishable features on these fracture surfaces. Section 10 will deal with the marks observed in detail.

Figure 8.4 Fracture surface of Gear A2-3 with corresponding results of the Magnetic Rubber Inspection
